**Enbridge Line 6B MP 608 Pipeline Release
Marshall, Michigan**

**Permanent Recovery of Submerged Oil and Oil-Contaminated
Sediments at Priority Locations**

Submerged Oil Recovery Summary Report

**Enbridge Energy
October 29, 2010**

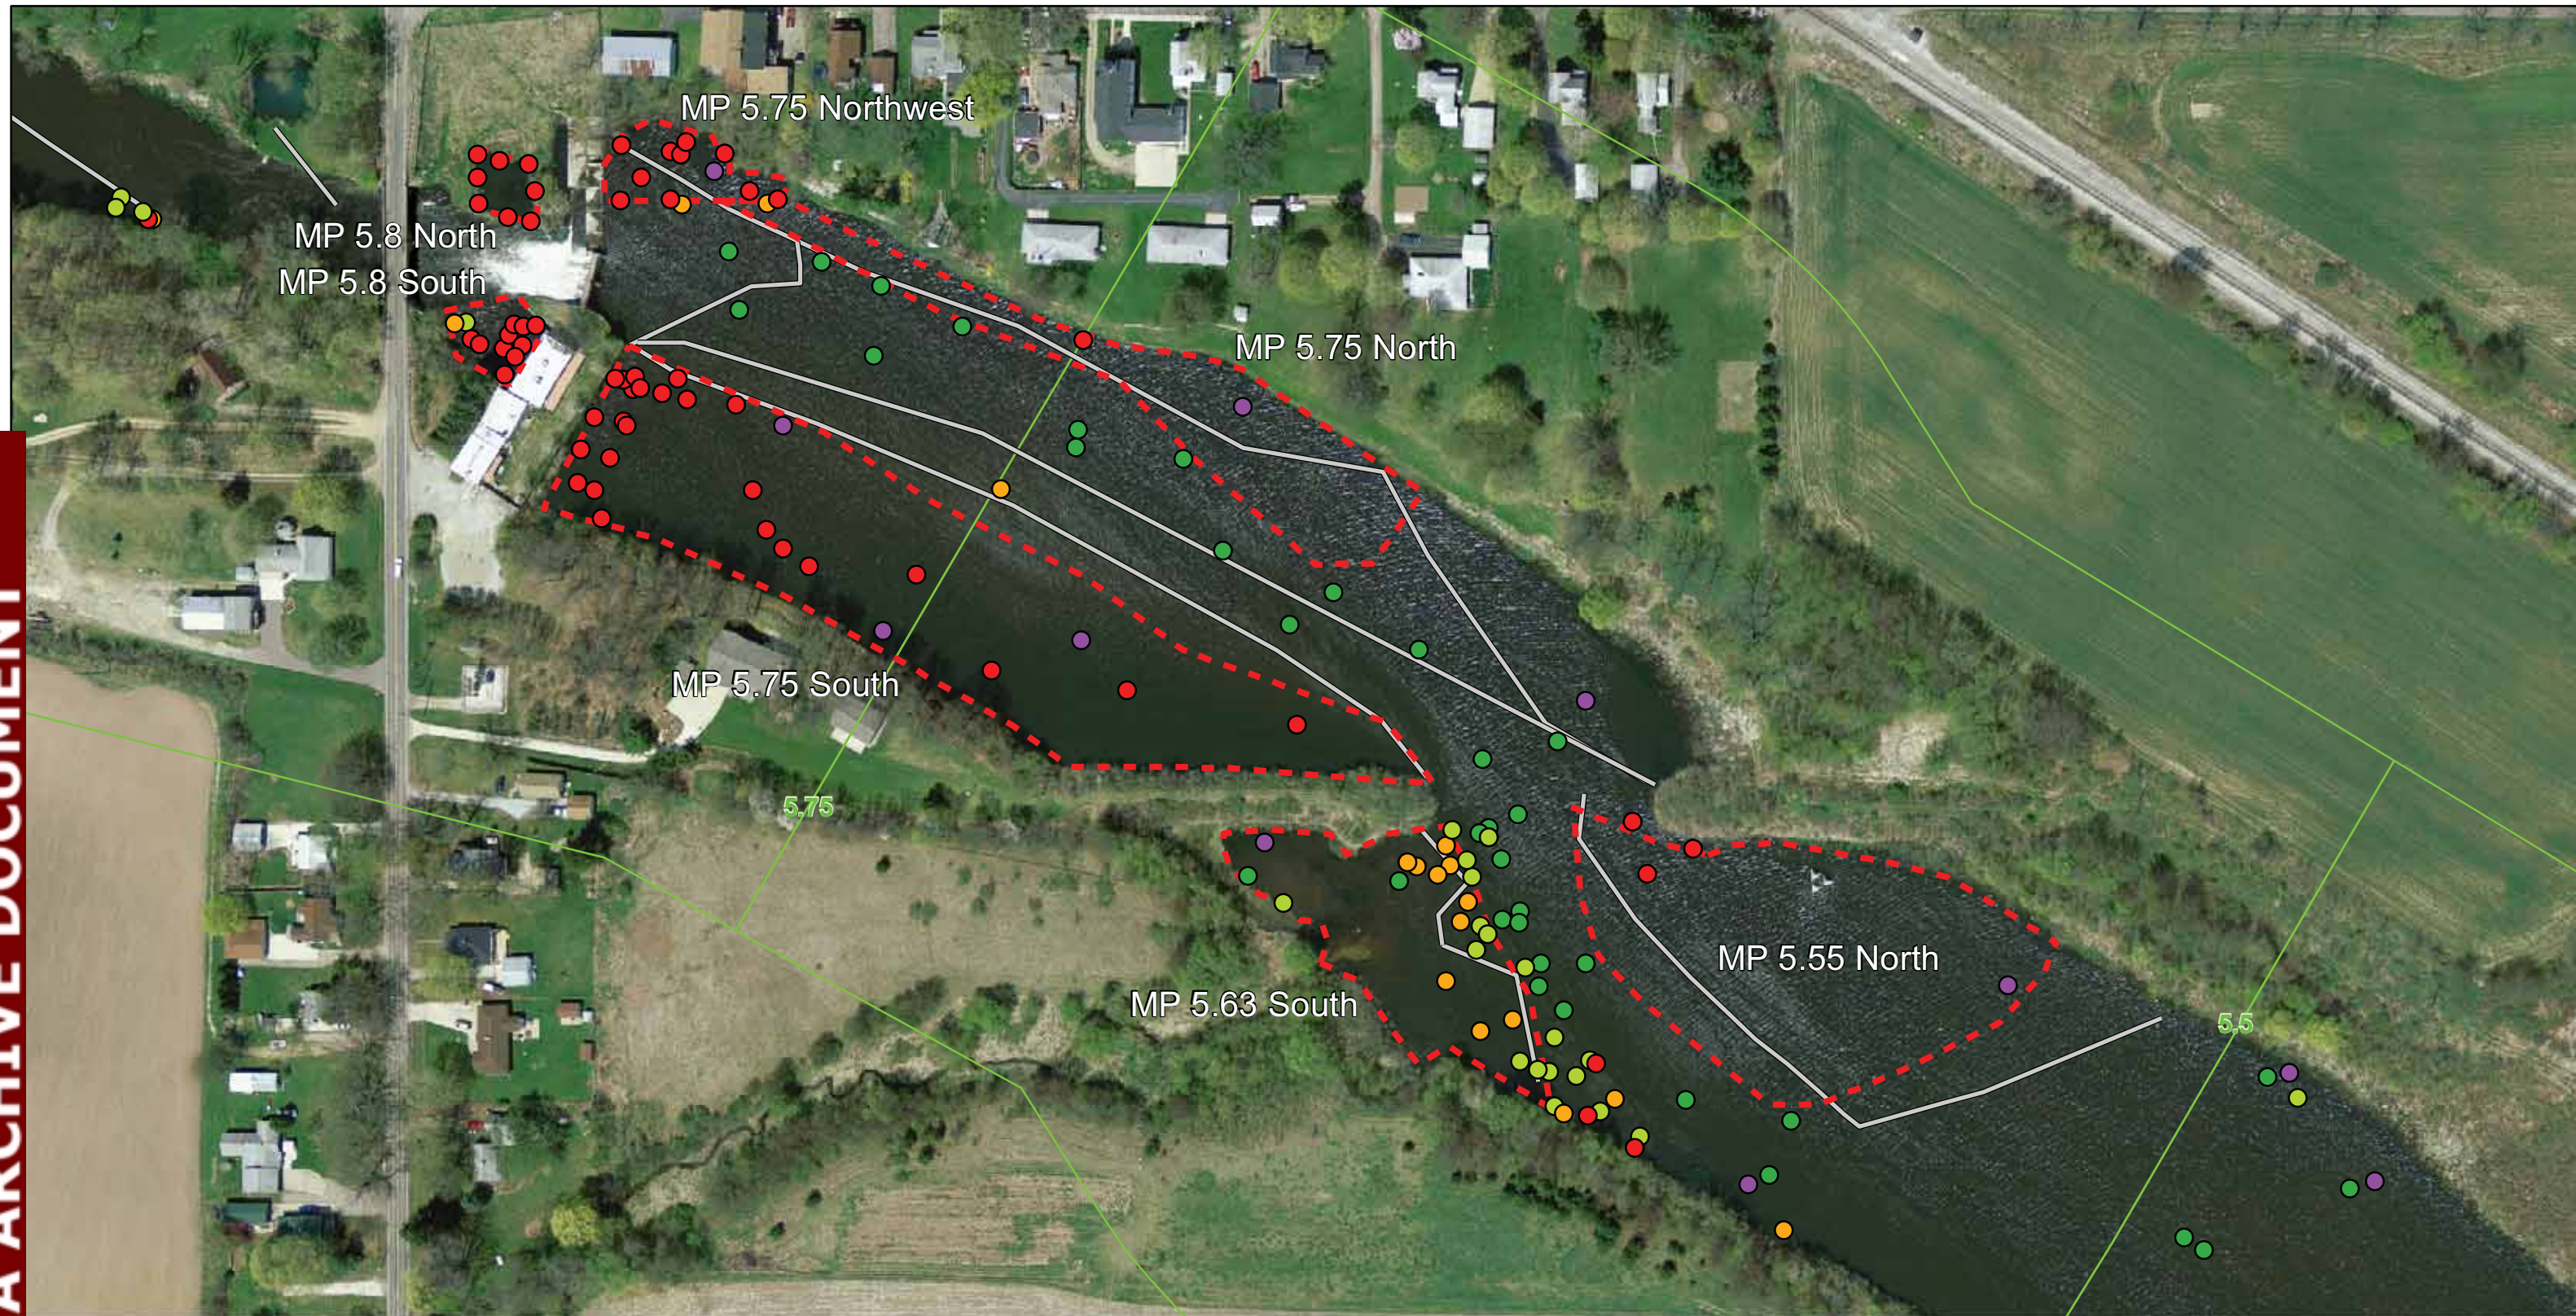
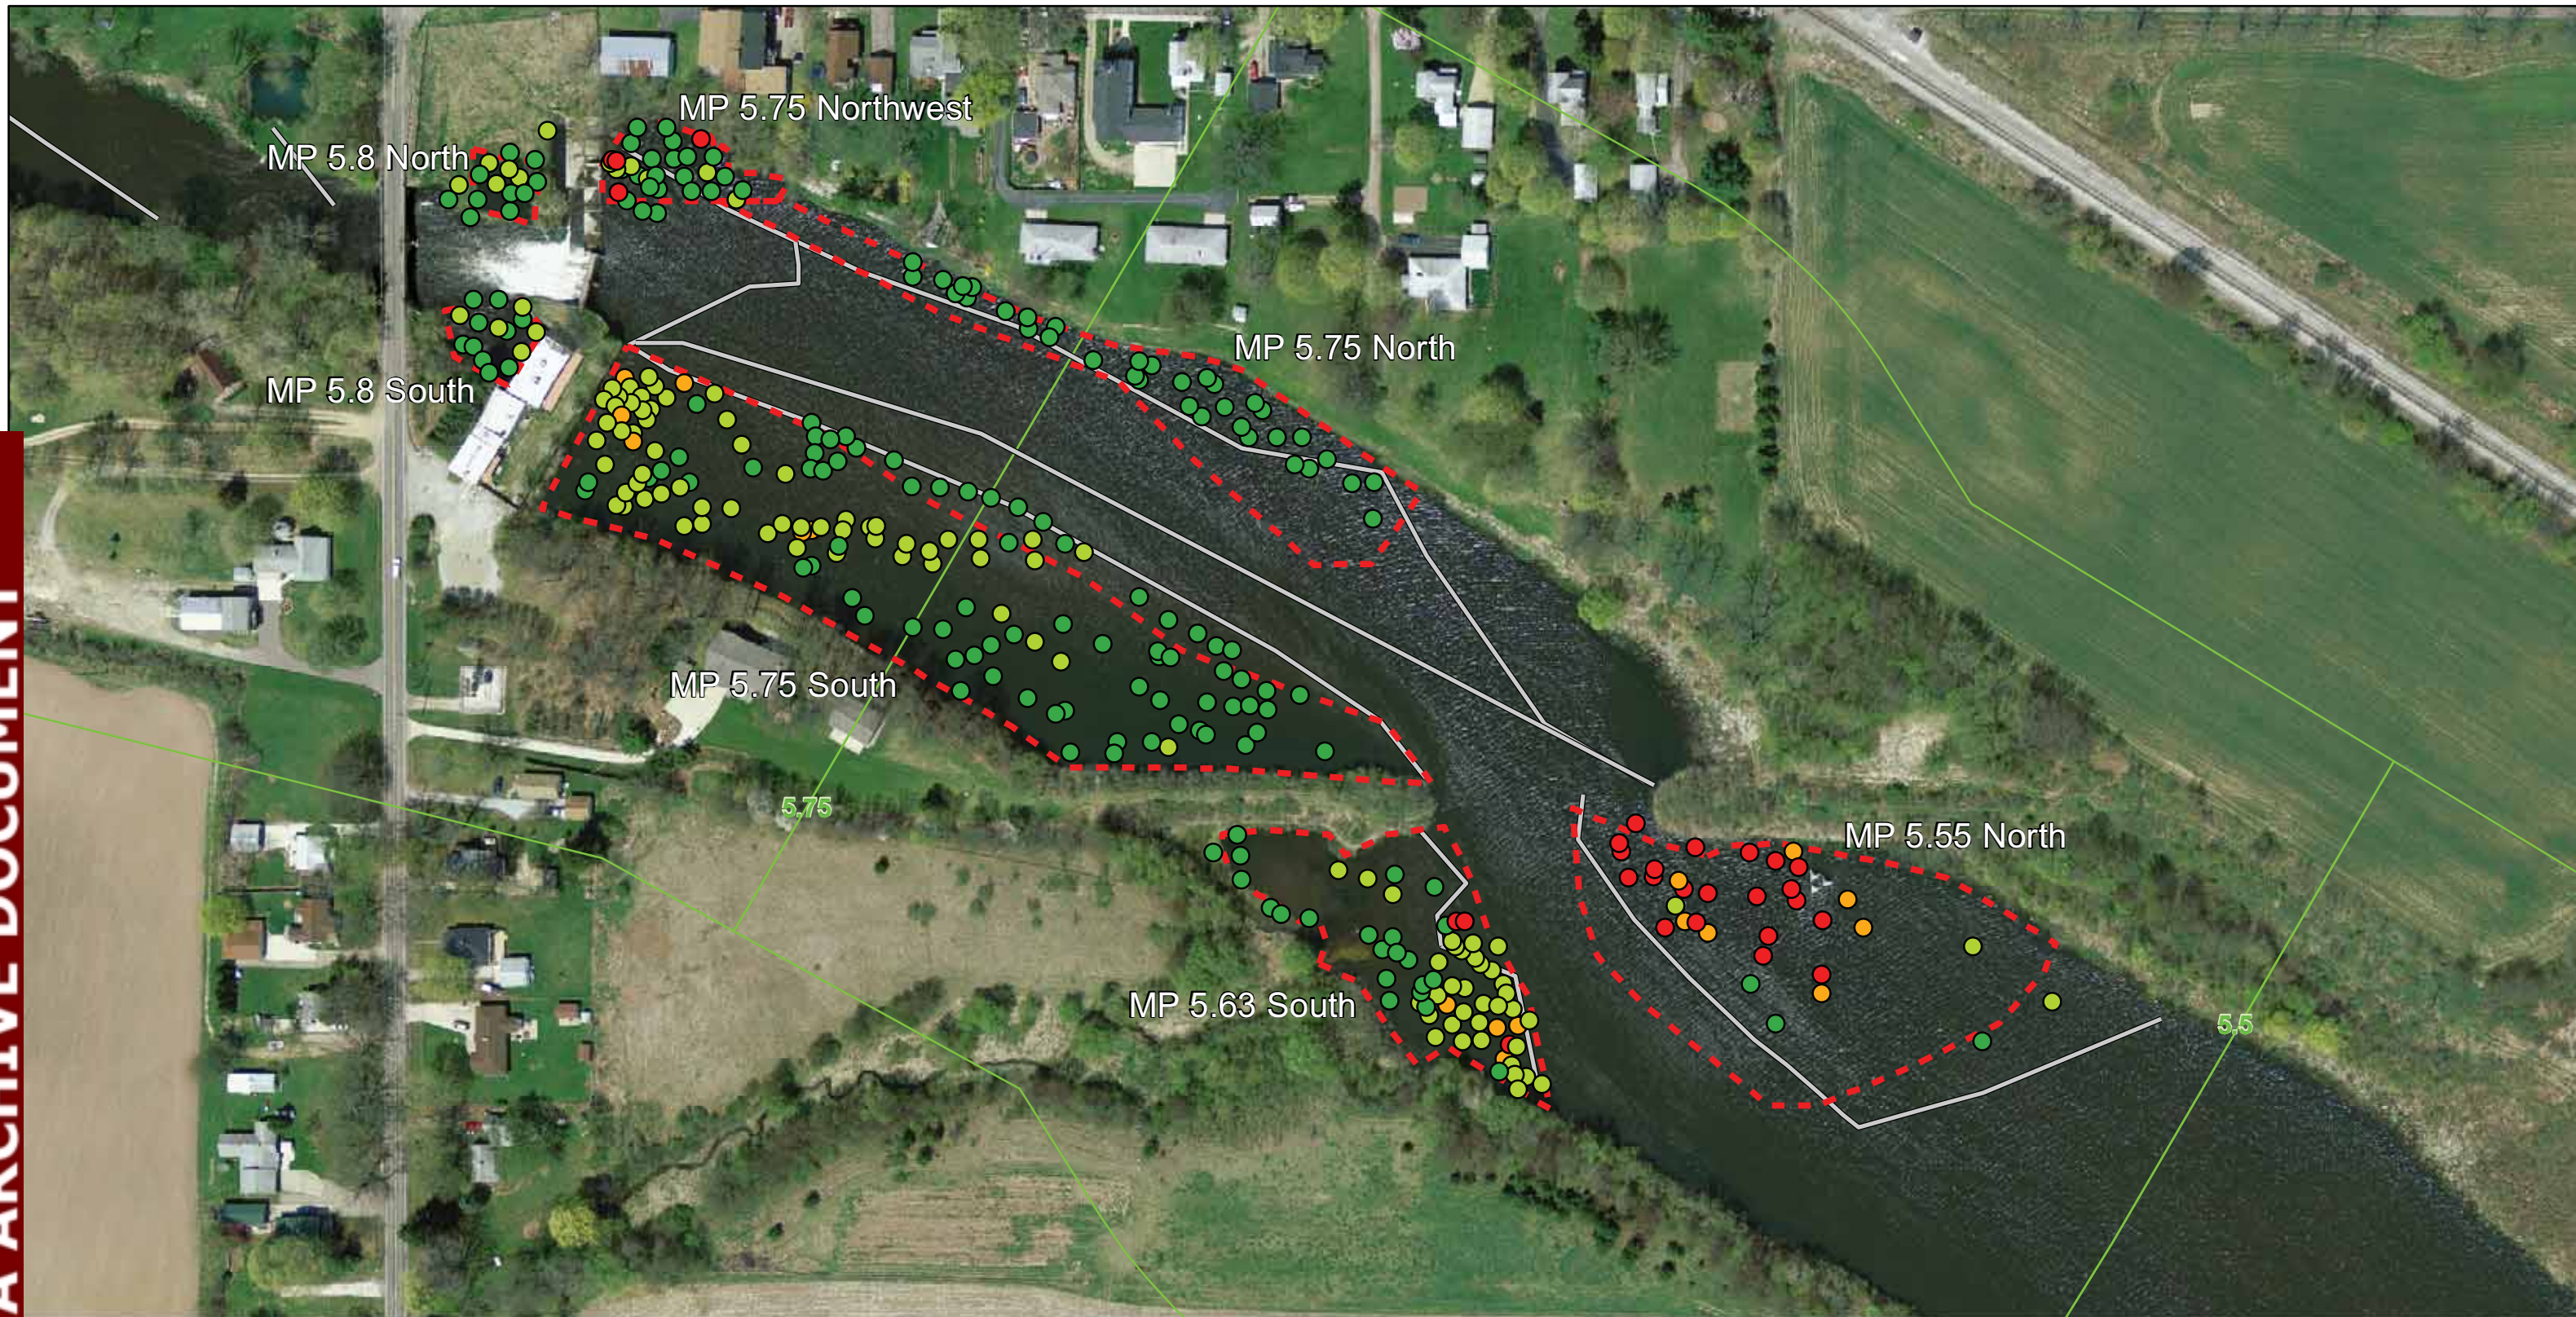
Site Location:	MP 5.55 North
Site Layout:	See Figure Attached
Description and Geomorphic Setting:	Shallow cove on right bank looking downstream, upstream of Ceresco Dam
Approximate Areal Extent:	~1.5 acres
Approximate Depth of Water:	0 to 1 foot near shore, deeper towards silt curtain
Sediment thickness:	2+ feet
Bed type:	Soft sediment
Data Collected:	
Poling (Y/N)	Y
Cores (Y/N)	Y
Lab analysis (Y/N)	Y
Community Description and Habitat Quality:	High quality habitat has been impacted. Aquatic beds dominated by <i>Peltandra</i> and <i>Nymphaea</i> have been cut. Potential fish spawning habitat for grass pickerel, Northern pike and other grass spawners. Turtle habitat and green frog observed. Also habitat for wading birds, shorebirds, rails, waterfowl and muskrat.
Containment:	Silt curtains; details not known
Access Issues:	None
Miscellaneous:	N/A
Recommendations:	ECO: Area has already been impacted by clearing of vegetation. Area may be dredged to address remaining oil, but mitigation will be required by MDNRE as high quality habitat has been impacted. SOTF: Combination of aeration and shoreline dredging

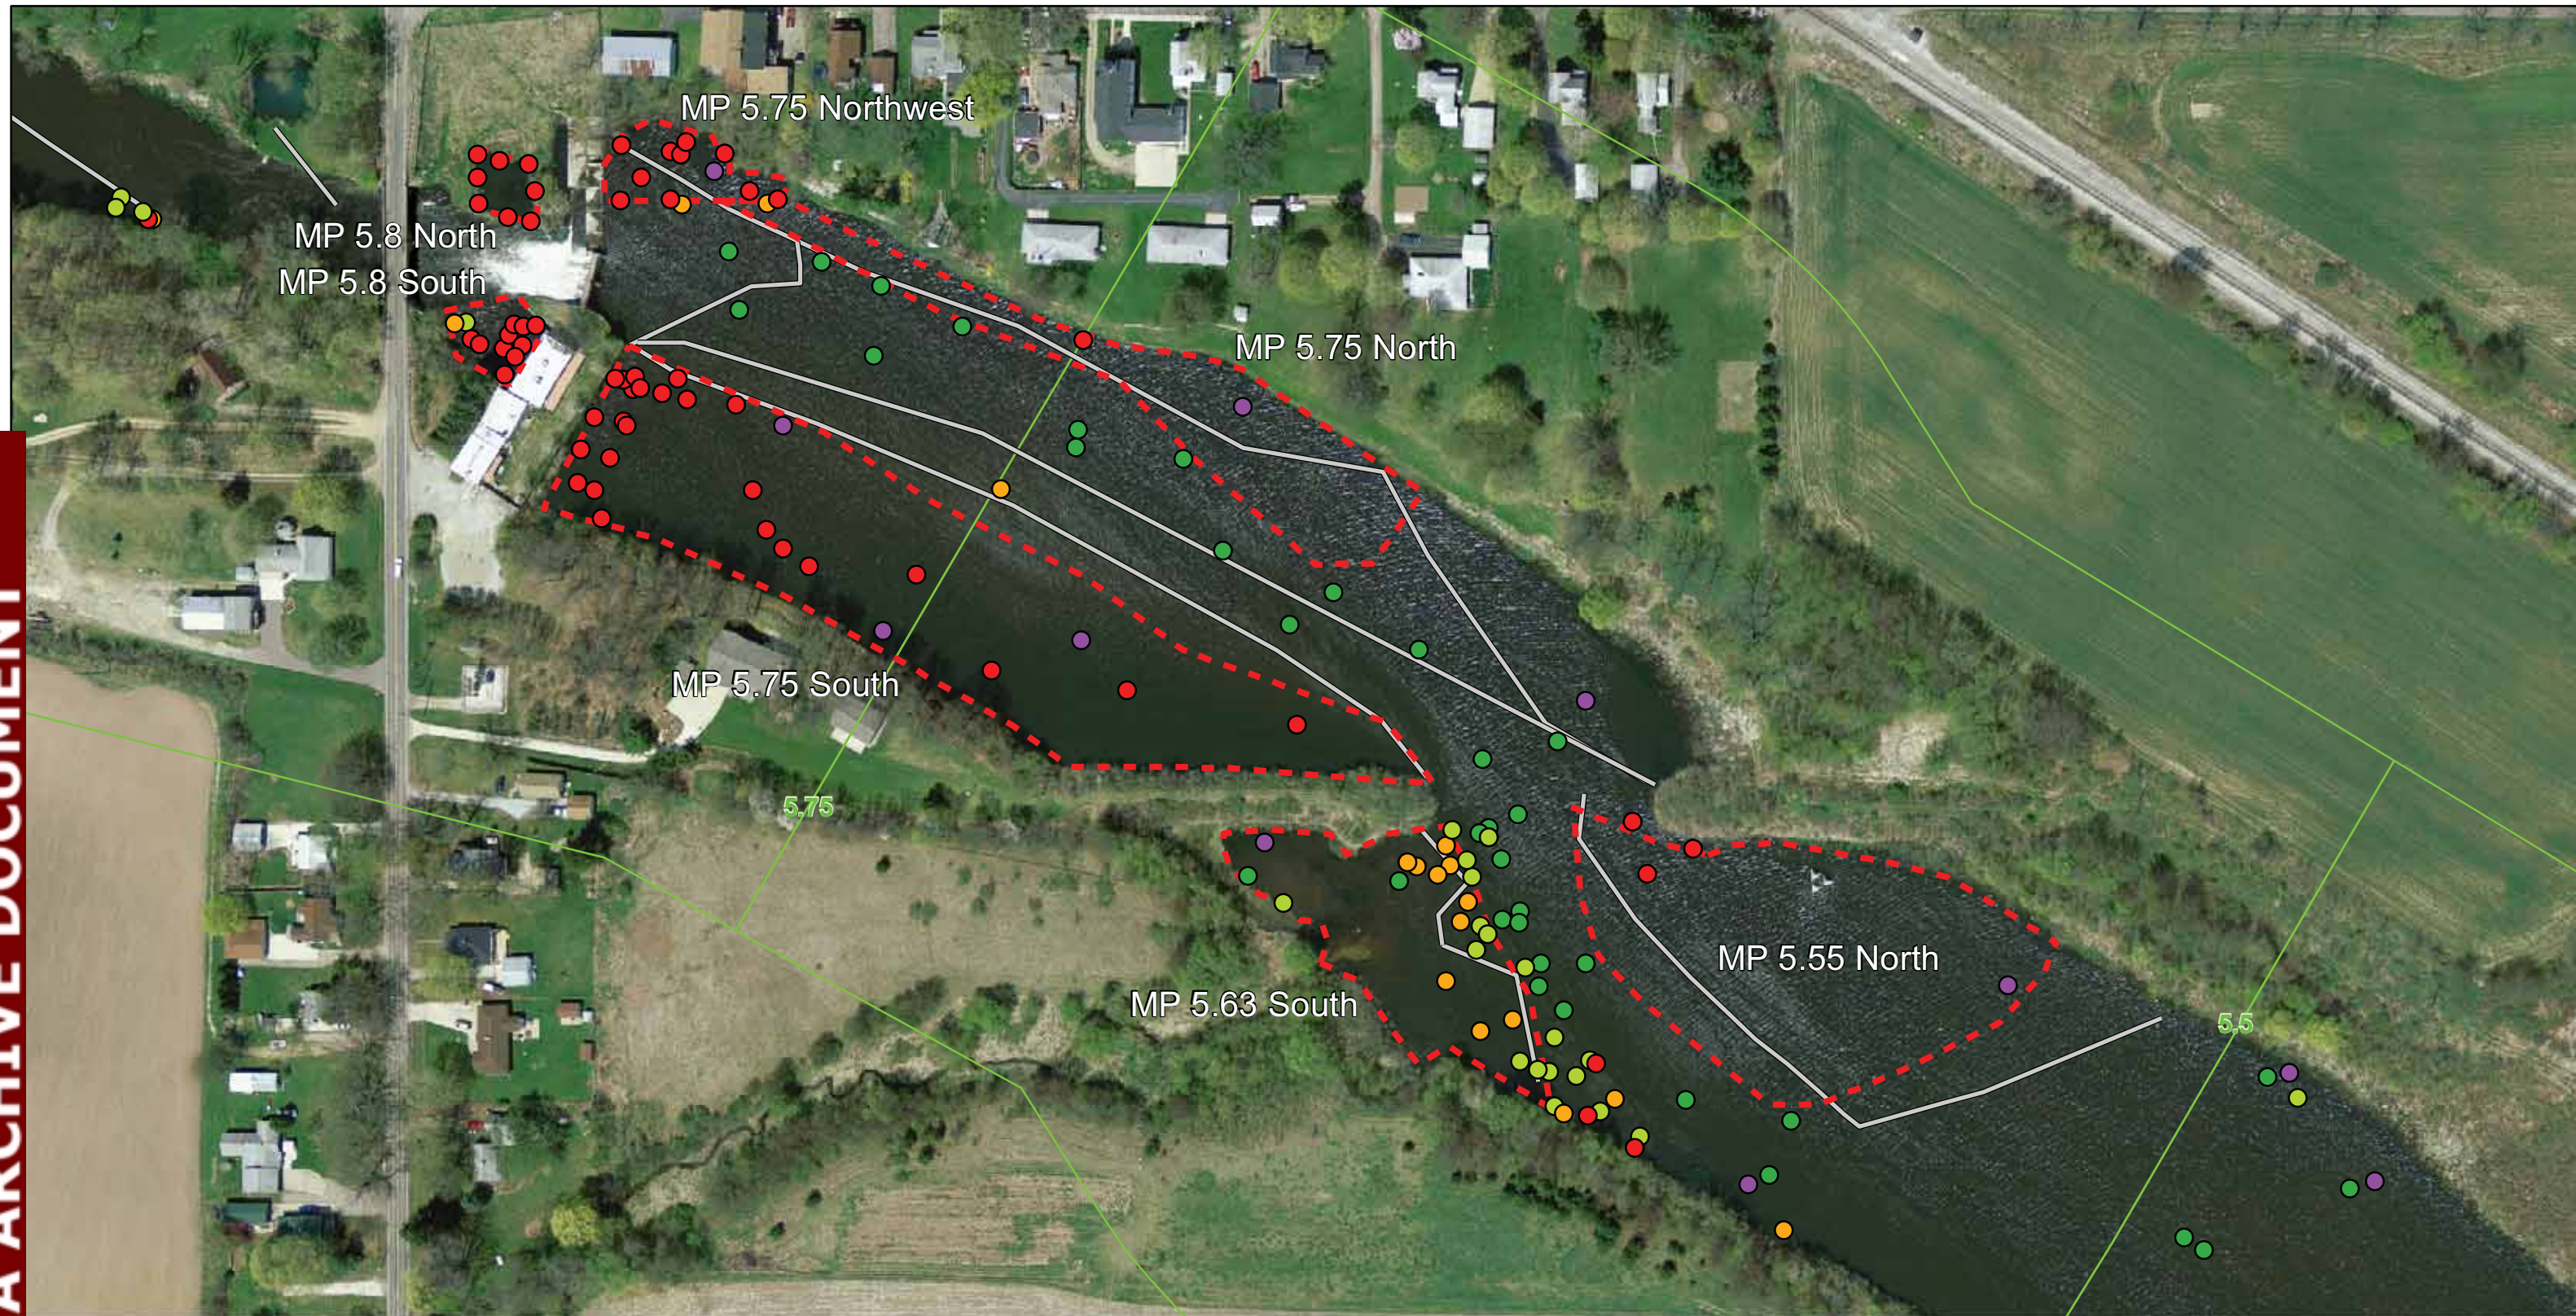
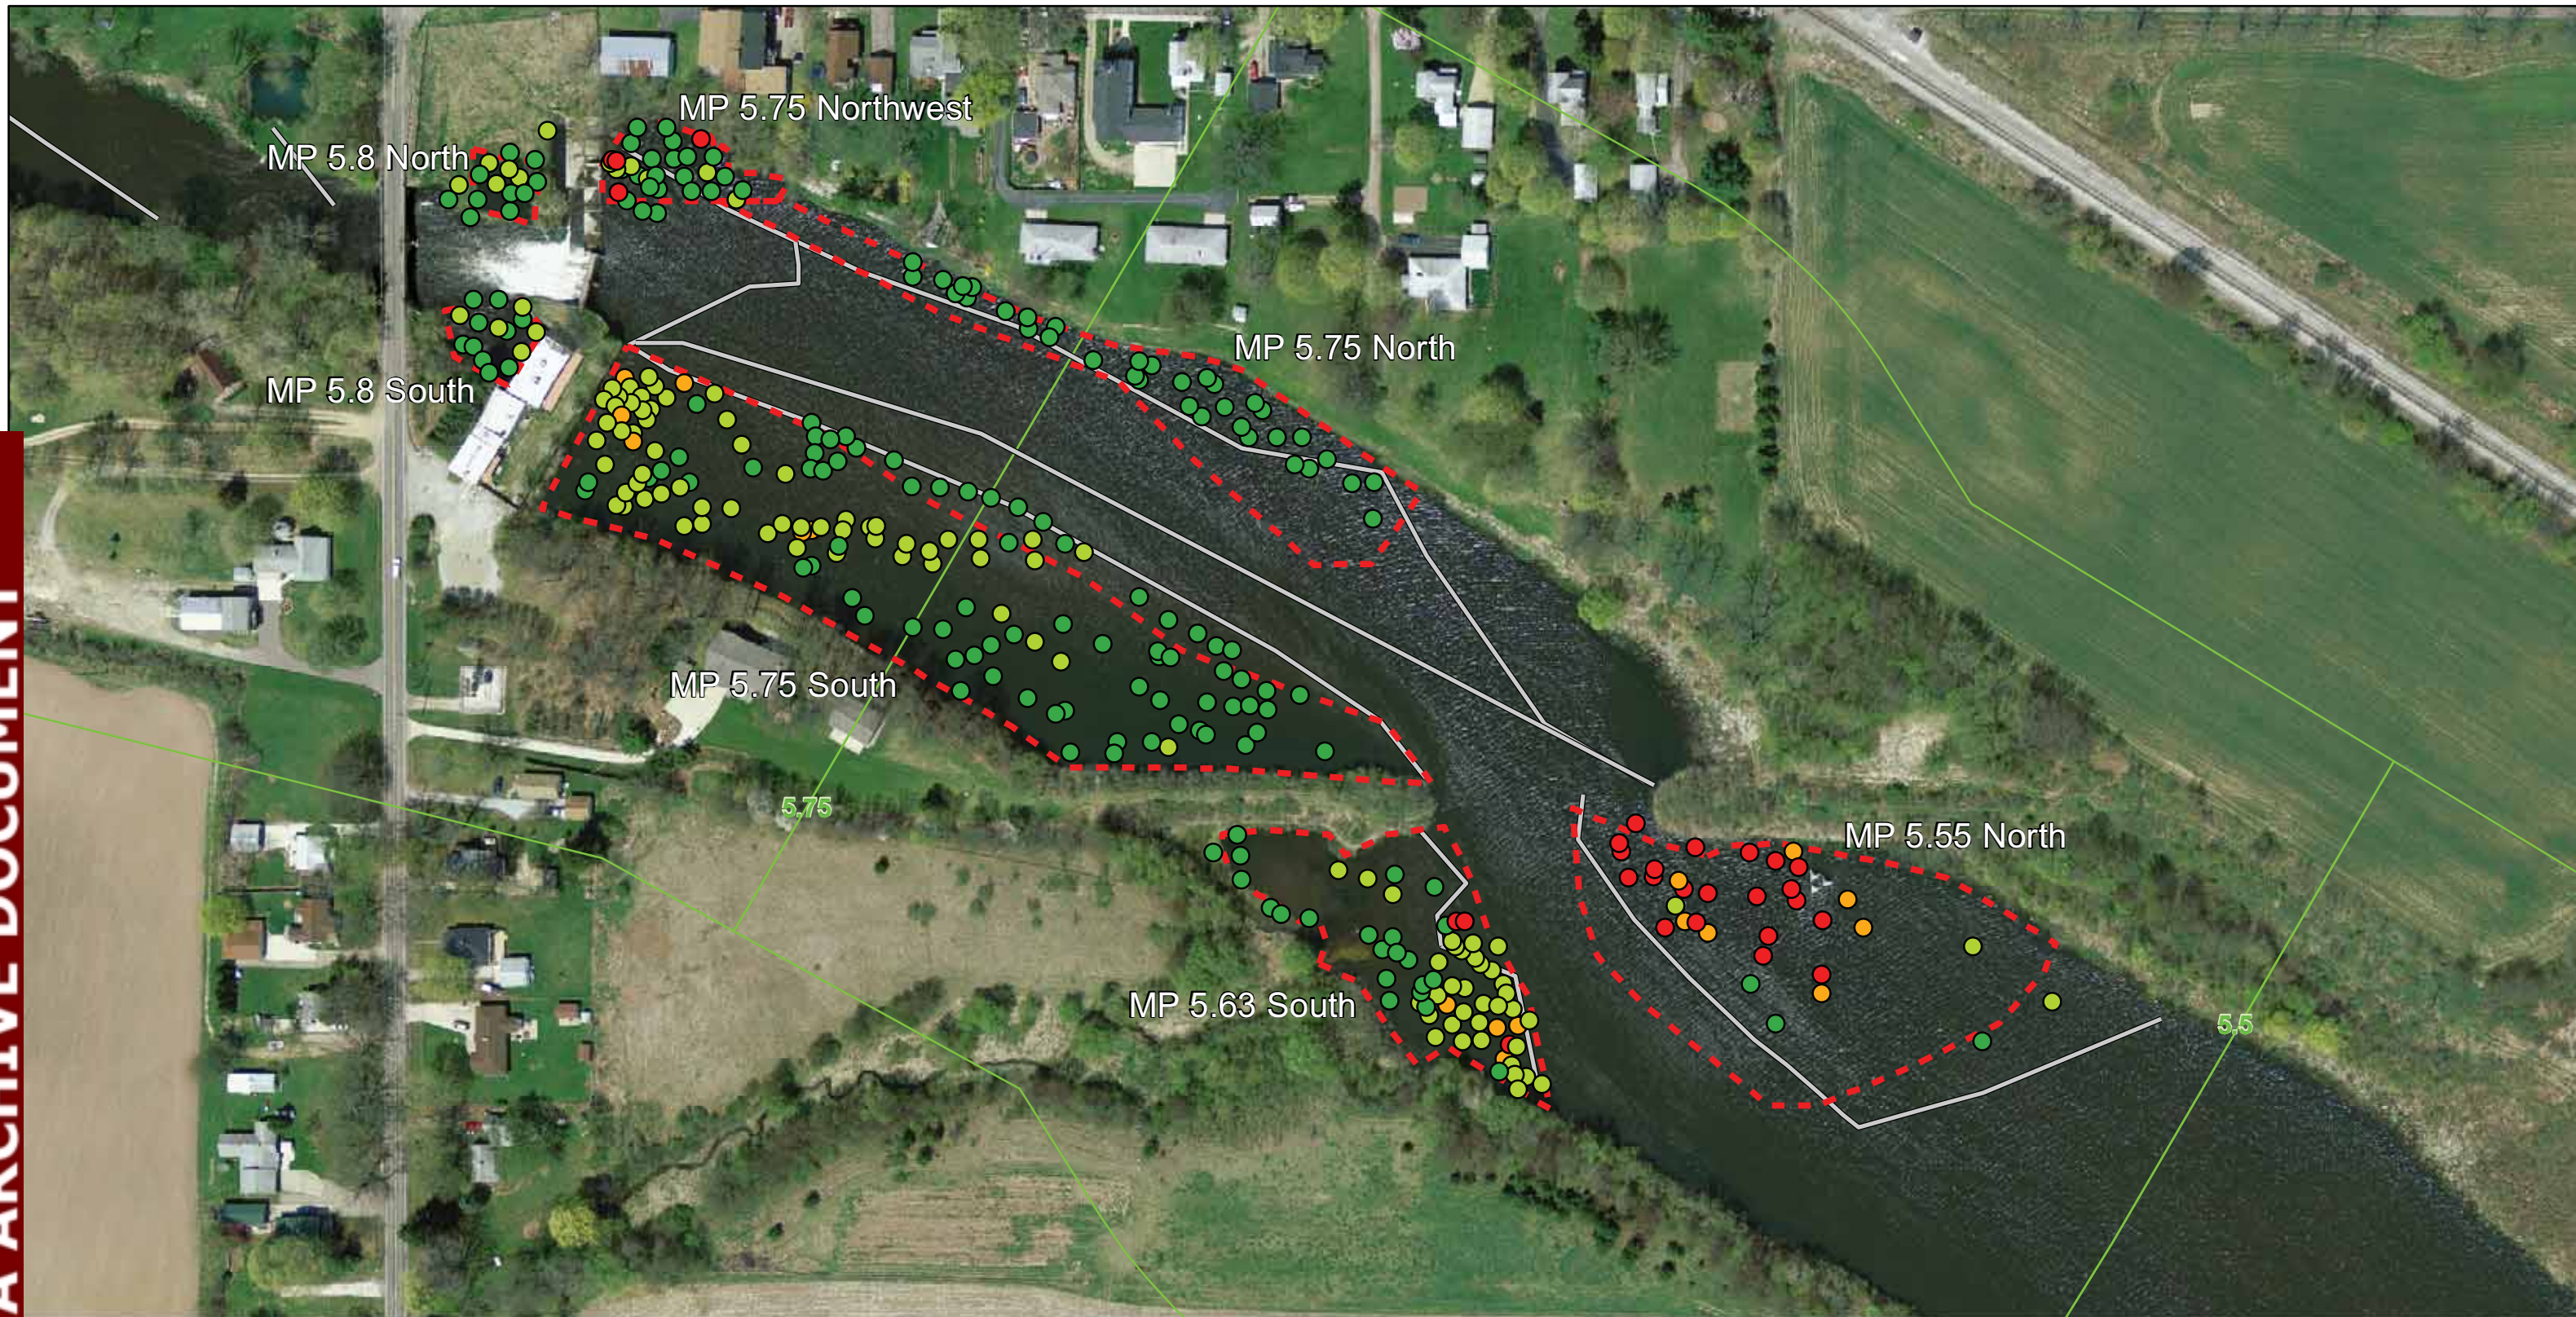
Site Location:	MP 5.75 Ceresco Dam South
Site Layout:	See Figure Attached
Description and Geomorphic Setting:	Upstream of Dam
Approximate Areal Extent:	~2.5 acres
Approximate Depth of Water:	0 to 1 foot
Sediment thickness:	4+ feet
Bed type:	Soft sediment
Data Collected:	
Poling (Y/N)	Y
Cores (Y/N)	Y
Lab analysis (Y/N)	Y
Community Description and Habitat Quality:	Not provided in Ecological Assessment Reports
Containment:	1000' silt curtain, 6' skirt
Access Issues:	None
Miscellaneous:	N/A
Recommendations:	ECO: Not provided in Ecological Assessment Reports SOTF: Hydraulic Dredging

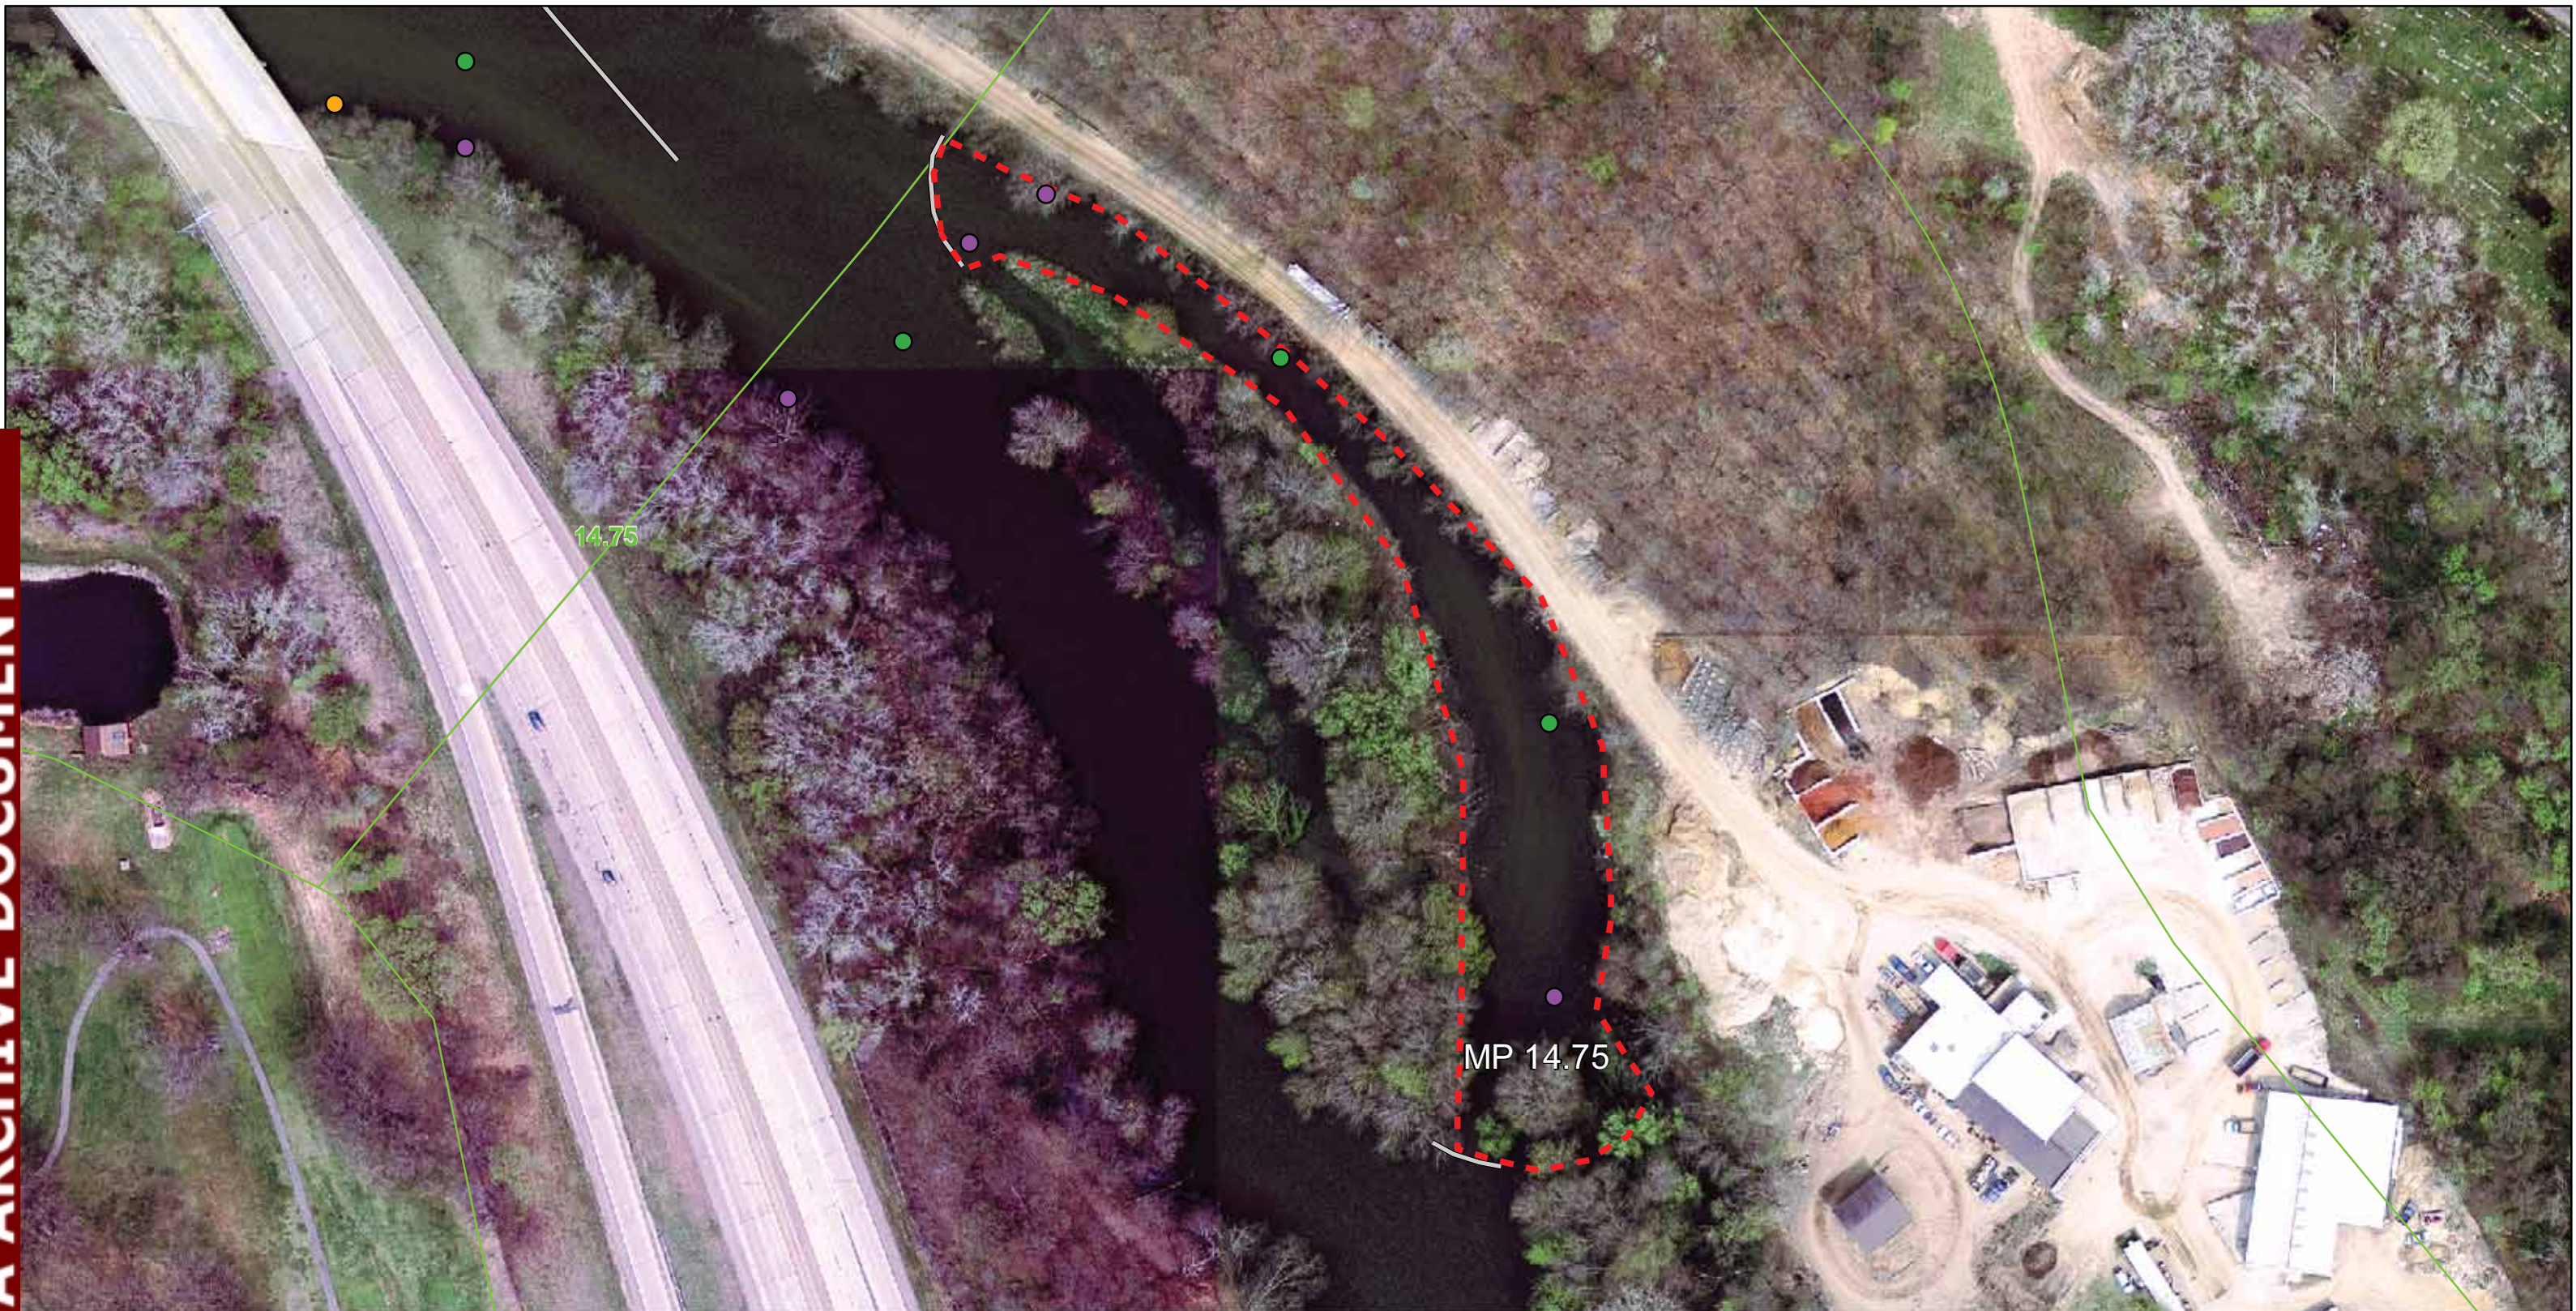
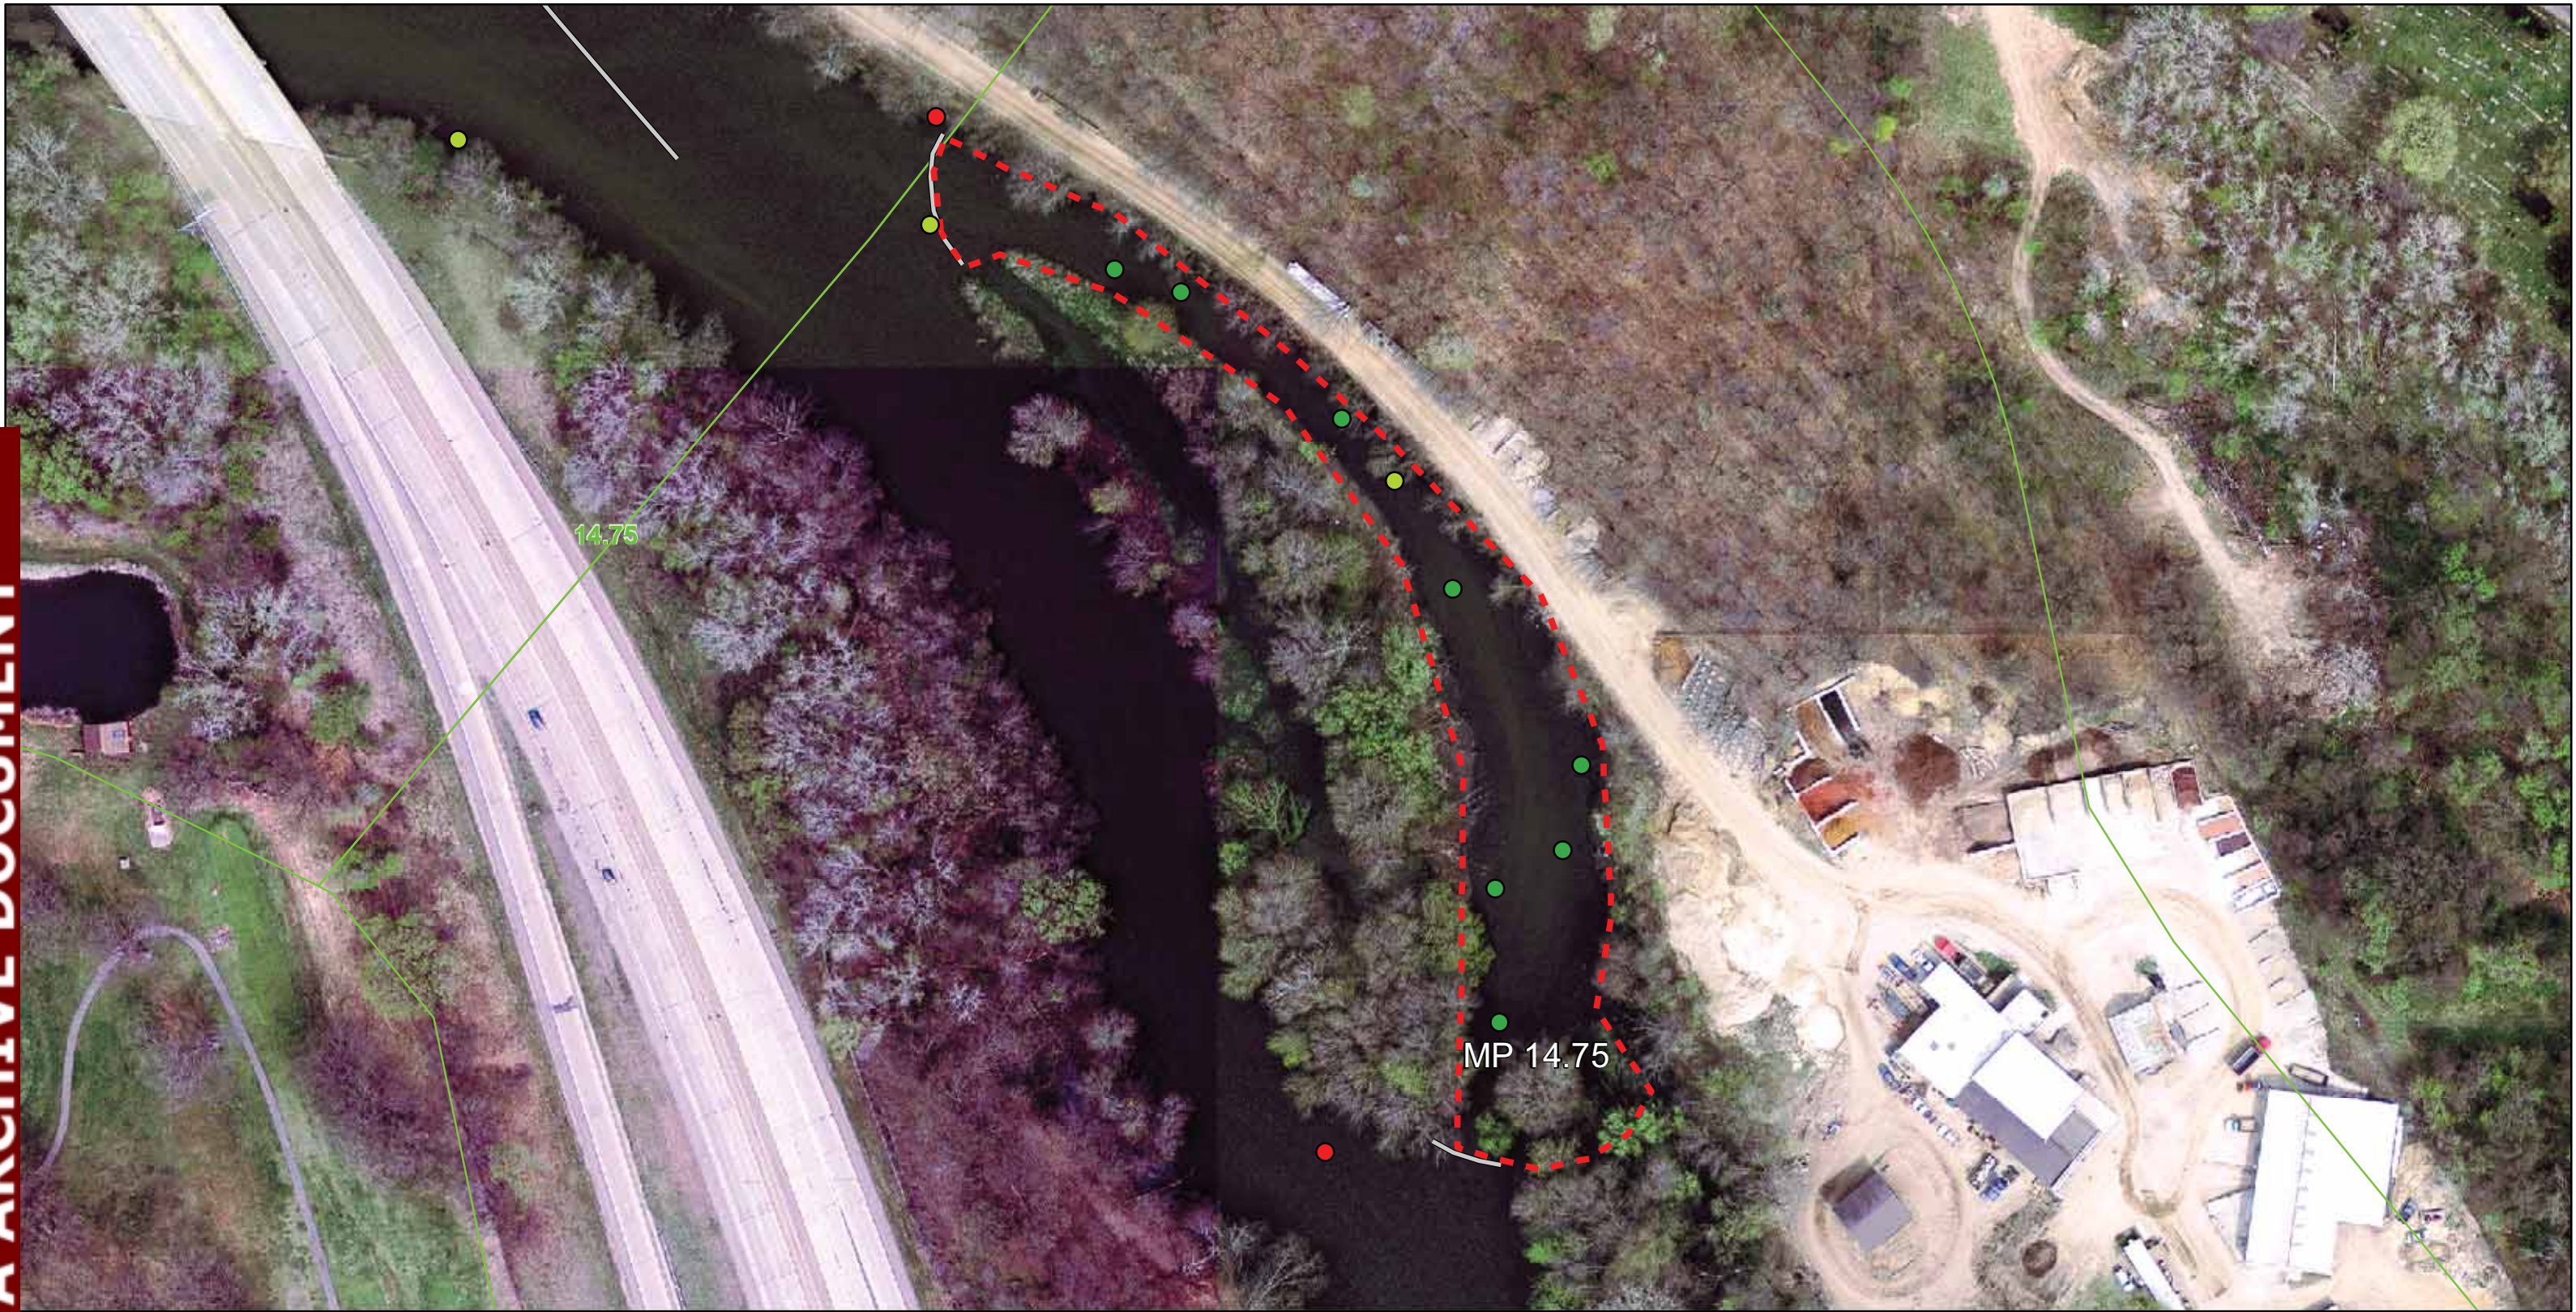
Site Location:	MP 14.75
Site Layout:	See Figure Attached
Description and Geomorphic Setting:	Overflow channel, right bank
Approximate Areal Extent:	~ 1 acre
Approximate Depth of Water:	2 to 3 feet
Sediment thickness:	0 to 1 foot
Bed type:	Silty sand over sand and gravel
Data Collected:	
Poling (Y/N)	Y
Cores (Y/N)	Y
Lab analysis (Y/N)	Y
Community Description and Habitat Quality:	Not provided in Ecological Assessment Reports
Containment:	Type unknown
Access Issues:	Easy
Miscellaneous:	Access via downstream side
Recommendations:	ECO: Not provided in Ecological Assessment Reports SOTF: Recommend that reasonably aggressive steps be taken to remove the oil. The technique employed would rely primarily on aeration, but may also include sediment skimming, flushing, raking or a combination of these.
